CIA/PIR-67207

CIA IMAGERY ANALYSIS DIVISION

TANK/ASSAULT-GUN
PROBABLE REGIMENT
MING-CHIANG, CHINA
(32 30N-114 00E)

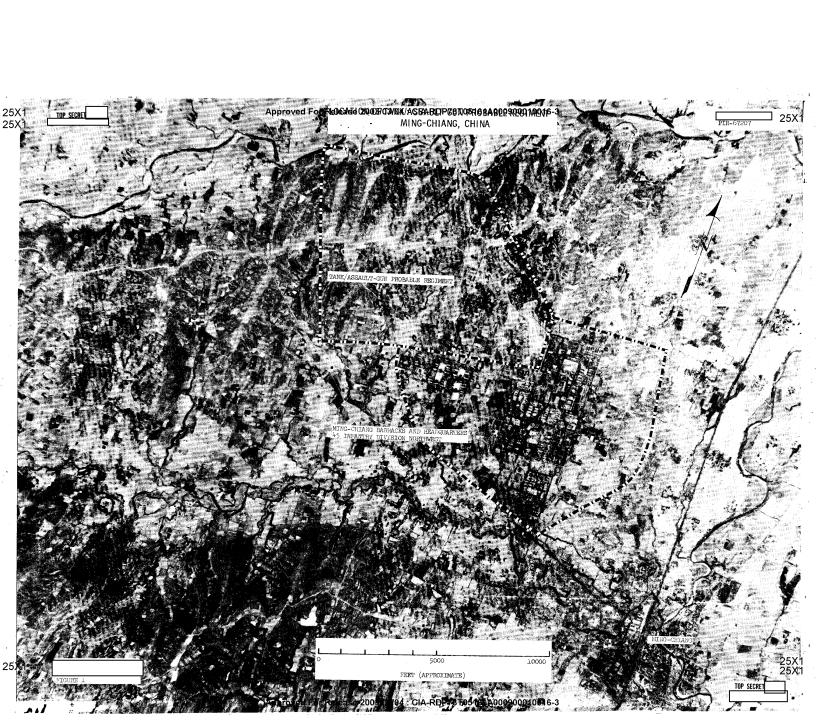
A tank/assault-gun unit, probably of regimental size, is located at 32 29 45N-114 00 20E on the northwest edge of the Ming-Chiang Barracks and Headquarters 45th Infantry Division Northwest 3 nm northwest of Ming-Chiang, China (See Figure 1).

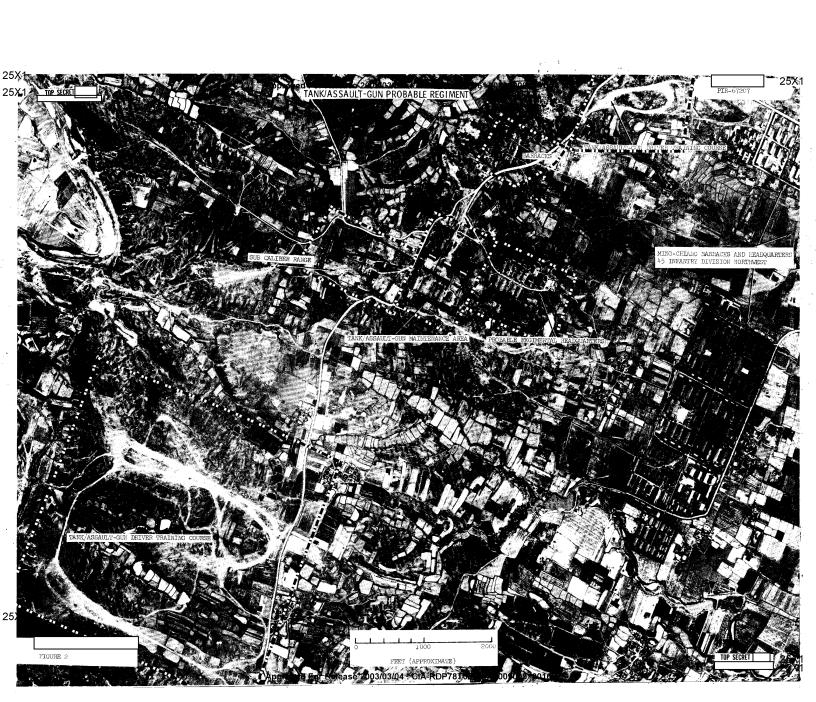
I SUMMARY: (See Figure 2)

The tank/assault-gun probable regiment consists of a probable regimental headquarters, a barracks area, a tank/assault-gun maintenance area, a subcaliber weapons firing range, and two tank/assault-gun driver training courses.

e. DRIVER TRAINING COURSES: (See Figure 2)

Two tank/assault-gun driver training courses are associated with the probable regiment.

The eastern course, on the crest of a small hill, is a closedcircuit, elliptical shaped training area. Photography of revealed a slight increase of earth scarring indicating increased activity in this area.

The western course follows along the crest of two hills and the valley between them and consists of a series of closed-circuit courses and one support building. An undetermined number of AAA and FA emplacements are located throughout the area.

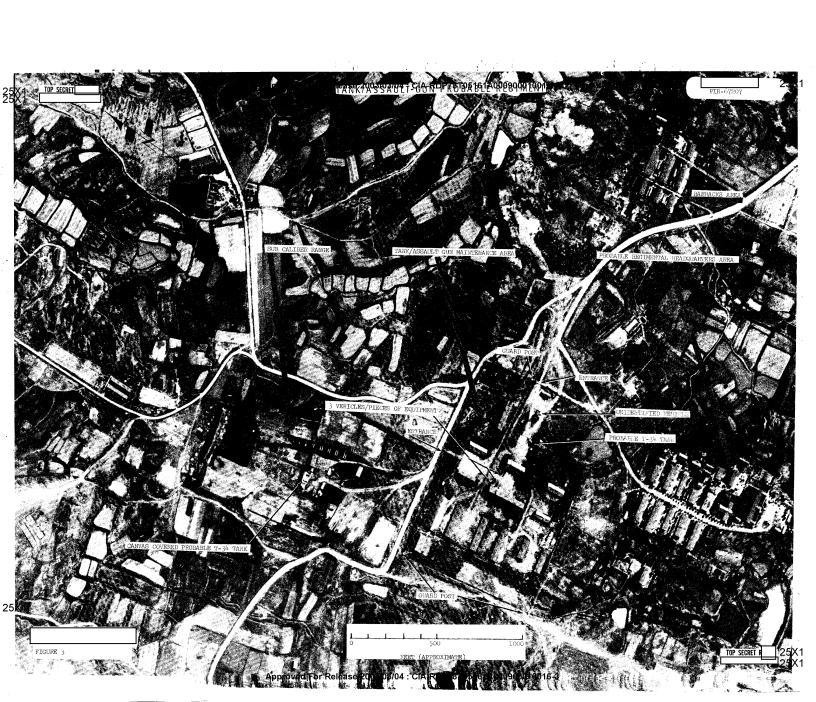
a. PROBABLE REGIMENTAL HEADQUARTERS: (See Figure 3)

The headquarters area, immediately south of the secured tank/assault-gun maintenance area, contains an "E" shaped headquarters building, an administration building, eight barracks (150 X 25 feet, 145 X 25 feet, 20 115 X 25 feet, 20 110 X 25 feet, 85 X 25 feet and 65 X 25 feet), a barracks/storage building, an equipment storage building, five small storage buildings, one messhall, 13 support buildings and a probable athletic field.

b. BARRACKS AREA: (See Figure 3)

This barracks area, immediately east of the tank/assault-gun maintenance area, contains one administration building, four 65 X 25 foot barracks, two 130 X 40 foot probable storage buildings, one probable equipment storage building and seven support buildings.

c. TANK/ASSAULT-GUN MAINTENANCE AREA: (See Figure 3)

This 675 X 950 foot generally rectangular-shaped area is fence secured with guard posts at the main entrance and the northwest and southwest corners of the installation. The maintenance area contains one 100 X 50 foot drive-through, monitor-roofed maintenance building, one 185 X 50 foot drive-through, monitor-roofed maintenance building; four 150 X 35 foot armored vehicle sheds, two 100 X 40 foot armored vehicle sheds, two vehicle sheds (100 X 40 feet and 80 X 30 feet), three maintenance/storage buildings (110 X 35 feet, 90 X 35 feet and 80 X 35 feet), 5 support buildings, one administration building, a possible communication tower, and four grease pits.

A probable T-34 tank, an unidentified vehicle and 3 vehicles/pieces of equipment were observed on photography. Scale of photography precluded observation of tanks and equipment on other missions.

d. SUBCALIBER WEAPONS RANGE: (See Figure 3)

This range is approximately 1,000 feet long measuring from the south road to the firing butt, and contains a range building, a target materials building and three small support buildings.

gagas Residual estados estados de la composição de la com A canvas-covered probable T-34 tank was observed at the firing line on photography. Scale of photography precluded observation of tanks or equipment on other missions.
